**Professional Property Inspections, Inc.**  
**1235 County Road 278**  
**Melissa, Texas 75454**  
**214-726-1335**

**Commercial Inspection Report**

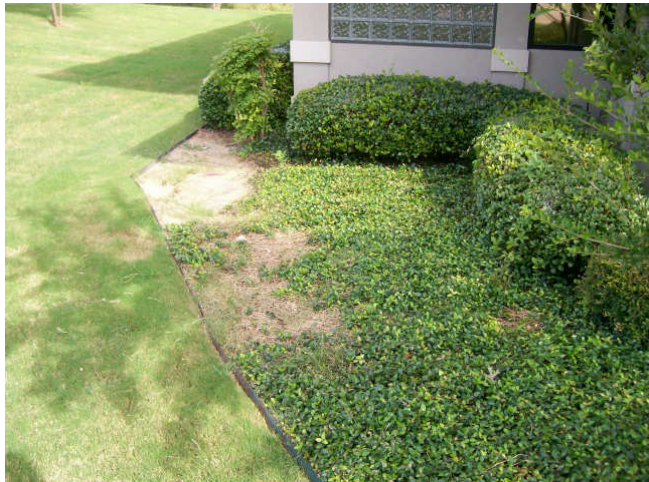
1. Poor drainage at the southeast section of the building.

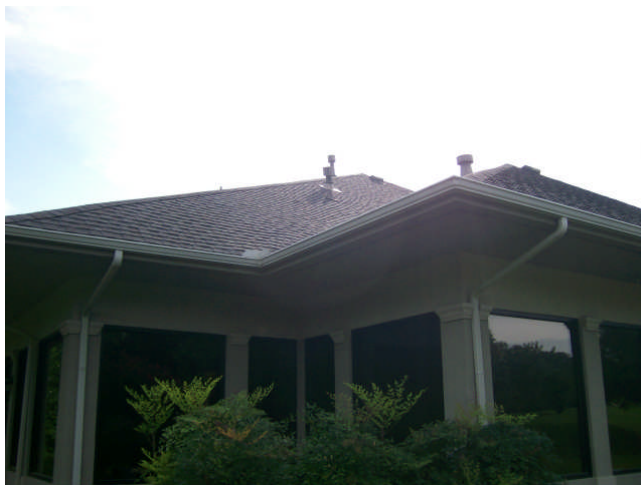
1. Plumbing vent boot pulled up at the southwest section of the building.
2. Seal all furnace vent pipe rain collars.
3. Extend gutter downspouts on the north and south sections of the building.
