Property Inspection Report

Prepared For: Sample Framing
(Name of Client)

CONSTRUCITON PHASE INSPECTION

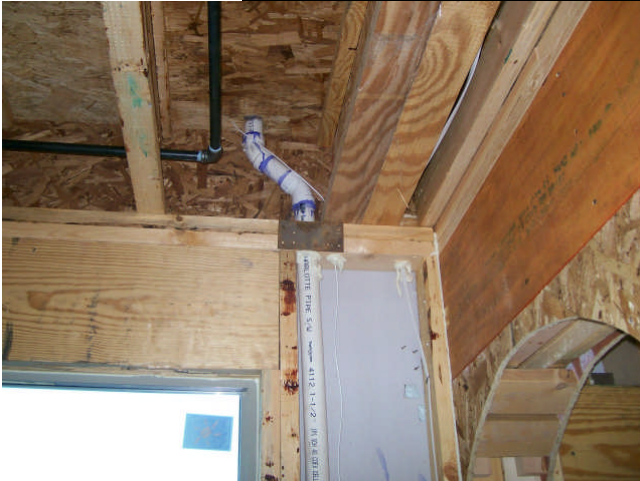
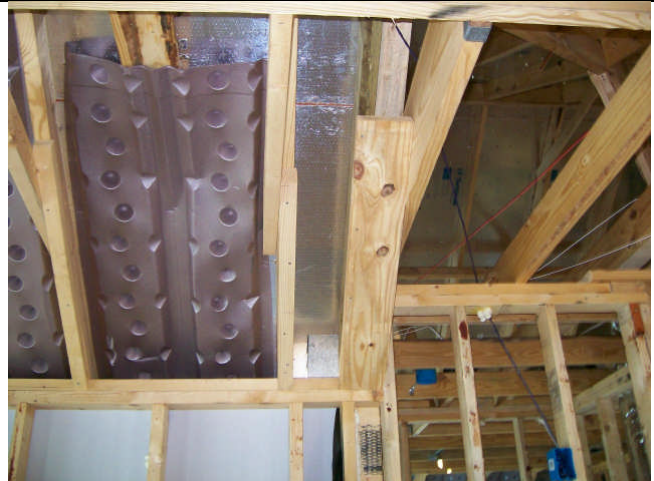
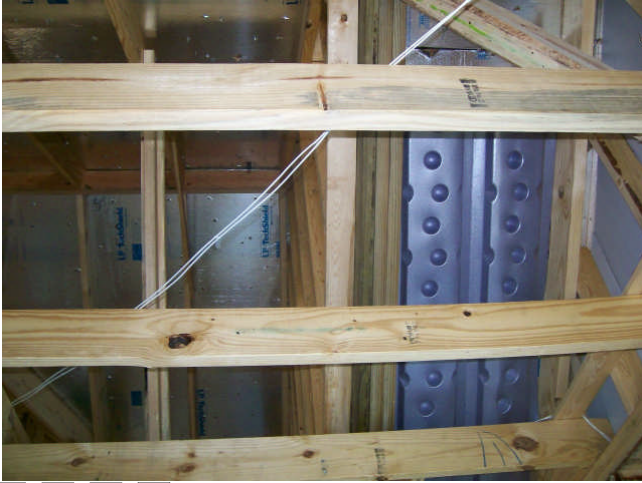
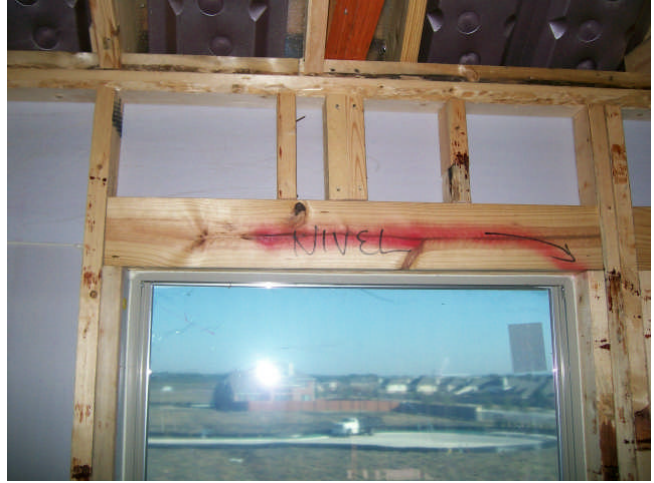
1. Add studs under load beam at the northwest corner of the family room.
2. Triple green wood not installed for brick support on the east side of entry gable.
3. Support the green wood brick support west side of the entry.
4. Recommend a 2x12 header over the northeast master bedroom window
5. Shim cripple at the master bedroom northeast window and master bathroom window over the bathtub.
6. Cables are on the outside of the stud at the east wall of the game room.
7. Seal opening around plumbing cleanout and sill plate on the west wall of the northern garage.

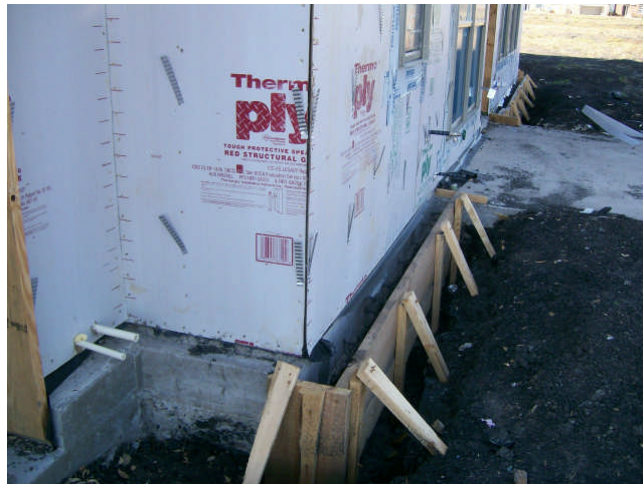
- 1. Replace all vapor barrier along the north side of the house.**
- Note: Vapor barrier should be installed under the sheathing.**
- Note: Brick ledge was added to the foundation footer wall along the north side of the house.**
