**Professional Property Inspections, Inc.**  
**1235 County Road 278**  
**Melissa, Texas 75454**  
**214-726-1335**

**Property Inspection Report**

**By:** Darrell G Tinglov #4304

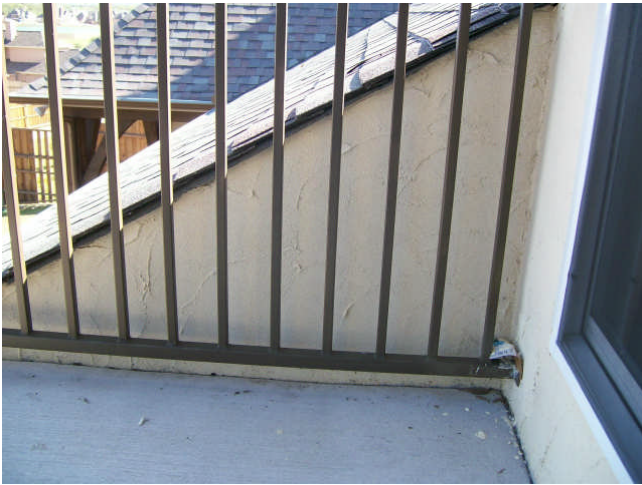
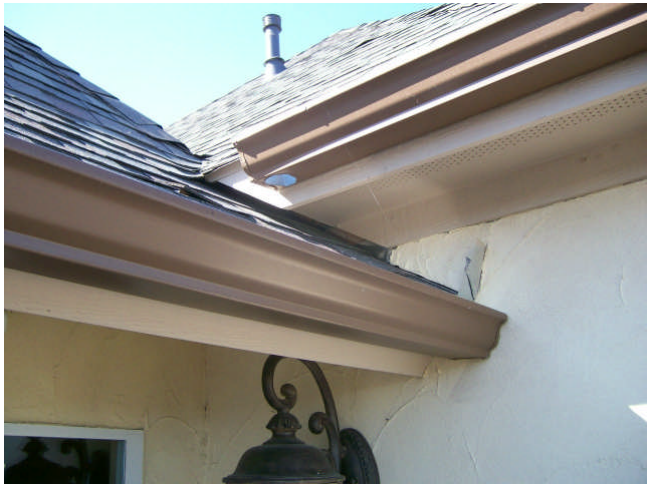
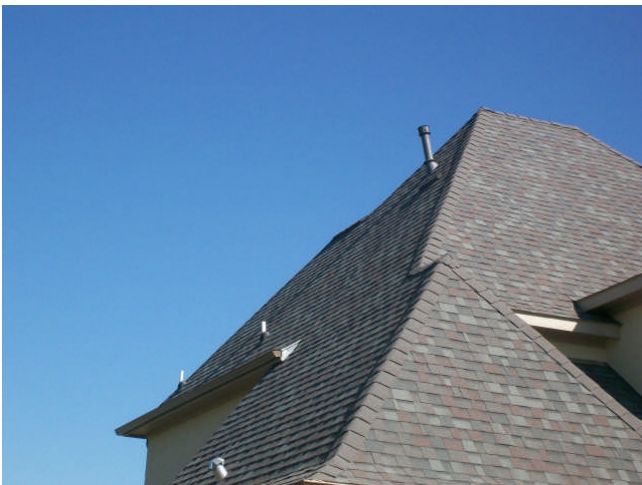
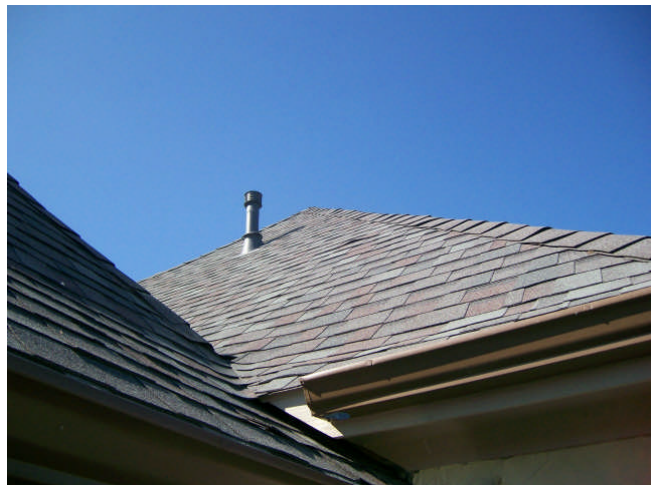
1. Drip edge flashing is not installed at the roof east of the balcony.
2. Install base flashing to fill voided area at the roof over the northwest section of the balcony.
3. Raised shingle on the east side of the upper northwest gable, upper northwest section of roof, and south section between eyebrow roof.
4. Remove toe boards on the upper west section of the roof.
5. Plumbing vent stacks need to be painted.
6. Caulk all nail heads at the plumbing vent boots and flashings.

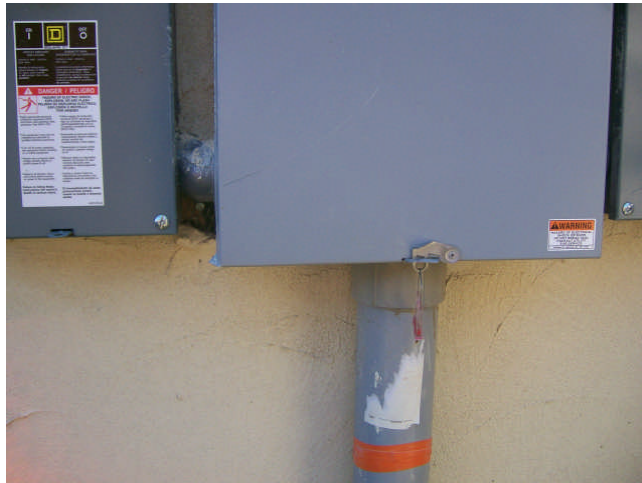
1. Repair openings in the stucco under the meter on the west side of the house.
2. Install brace at the pool bath roof.
3. Install cover over the plumbing cut off valve in the utility closet.

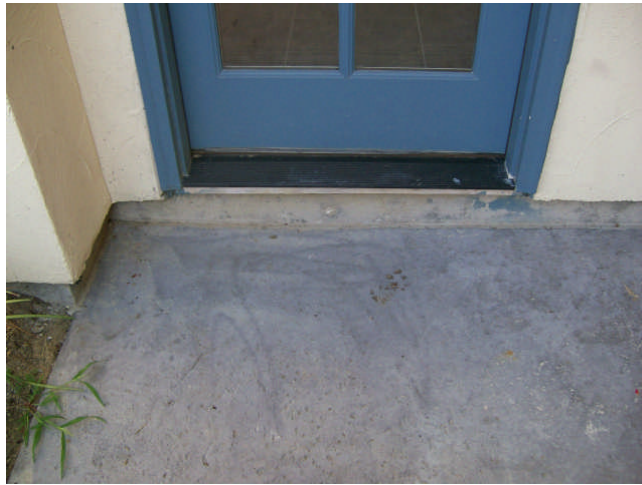
1. The downstairs west pool bath door does not seal tight. Note: Water damage to the base boards in the bathroom on either side of the door and southeast corner of the bathtub.
2. Southwest exterior door to driveway does not seal tight.
3. Southwest formal dining room door does not seal tight.
4. Balcony door does not seal tight.
5. Support thresholds at the west pool bath door, southwest driveway door, and garage entry door.

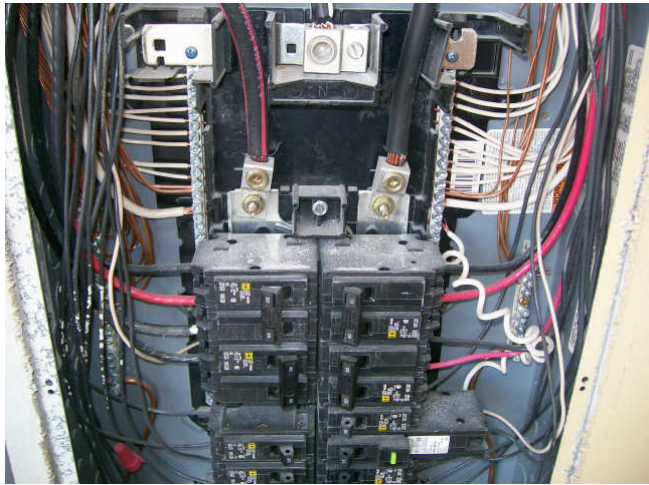
The panel boxes are located in the garage.  
 1. The grounds and neutrals should be isolated in the southeast panel box.

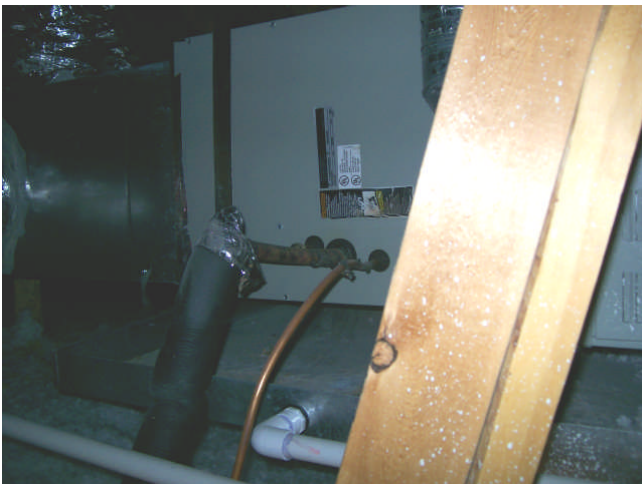
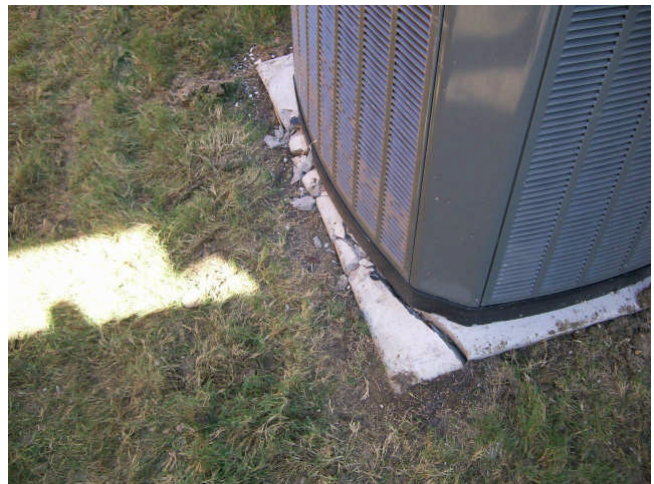
1. Insulate the suction line at the upper east evaporator coil and upper evaporator coil.
2. The southwest A/C condensing unit slab is cracked.
3. None of the A/C units are cooling properly.
4. Recommend an Air zone system for the new addition upstairs.
